Mount Hood  
National Forest  
Water Quality  
Best Management  
Practices (BMP)  
Monitoring Report  
Fiscal Year 2013

Prepared by: [Todd Reinwald, Soil and Water Program Manager, Mt. Hood NF HQ](#)  
Contributors: [Barlow, Clackamas River, Hood River, and Zigzag Ranger Districts](#)

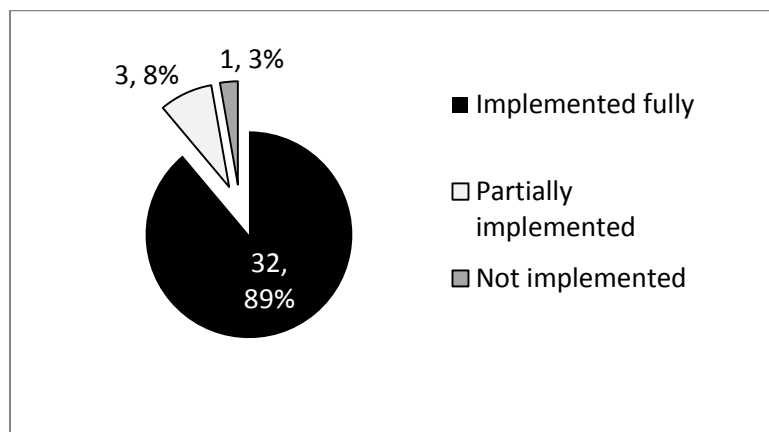
Figure 3. BMP implementation monitoring results for all MHNH projects monitored in 2013.

Of the 36 Core BMPs monitored for **implementation**, 89 percent were implemented fully as prescribed. Three BMPs were partially implemented, and there was one that was not (Figure 3). At every activity site there were BMPs that were fully implemented as intended, but at 4 of them there was a degree of deviation from full implementation.

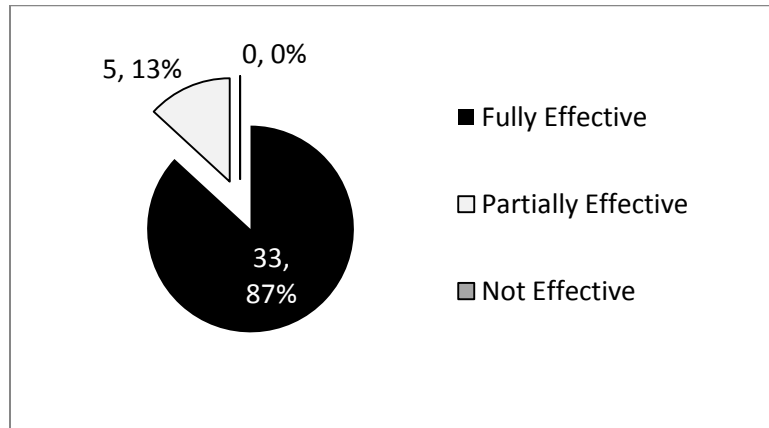
Figure 4. BMP effectiveness monitoring results for all MHNH projects monitored in 2013.

that were implemented only partially as prescribed. The magnitude of effect to aquatic and water resources however was considered to be minimal, so they were determined to be partially effective (Figure 4). Some unintended effects (i.e., small erosion features) were observed on-site, but evidence that prolonged and extensive transport of sediment to aquatic and water resources had occurred was not observed, so the effects are not considered to be substantially accelerated beyond the expected range of magnitude.
